TECHNICAL SERVICES ADVISORY MEMO

TO: Distribution
FROM: Technical Services
DATE: March 15, 2018
SUBJECT: NIC Panel Screw Attachment

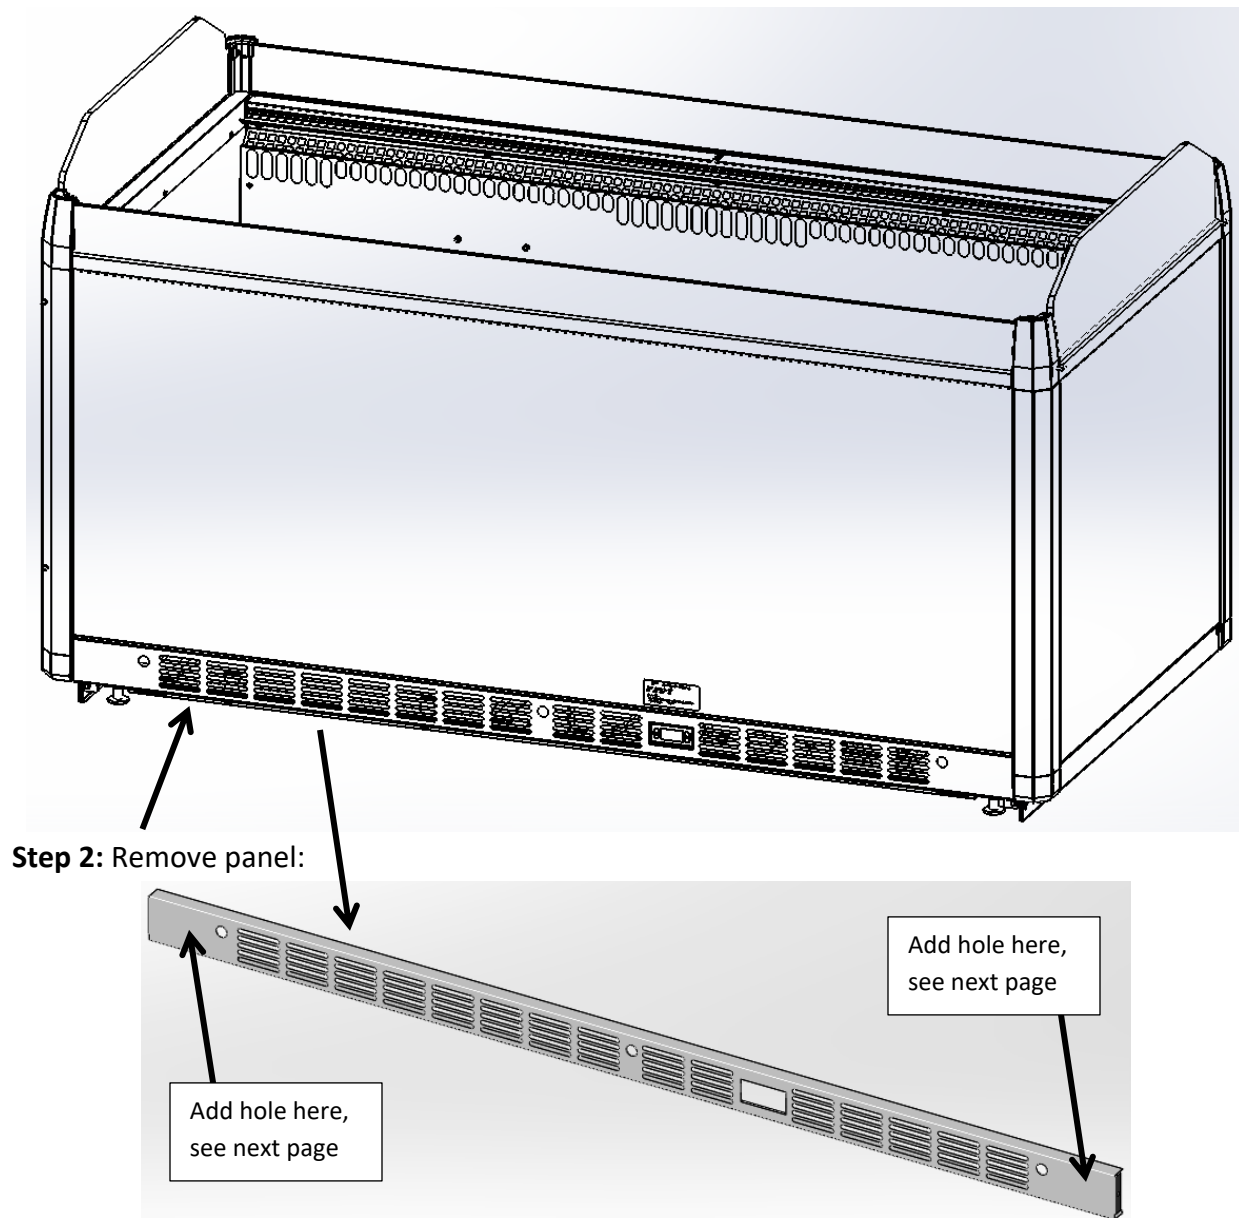
Lower NIC183S01 panel magnets may not hold the panel in place. To remedy:

Step 1: Obtain two #8 sheetmetal screws at least ¼ inch long, with pointed tips. Stainless steel, Phillips truss or pan head would have better appearance, but not required.

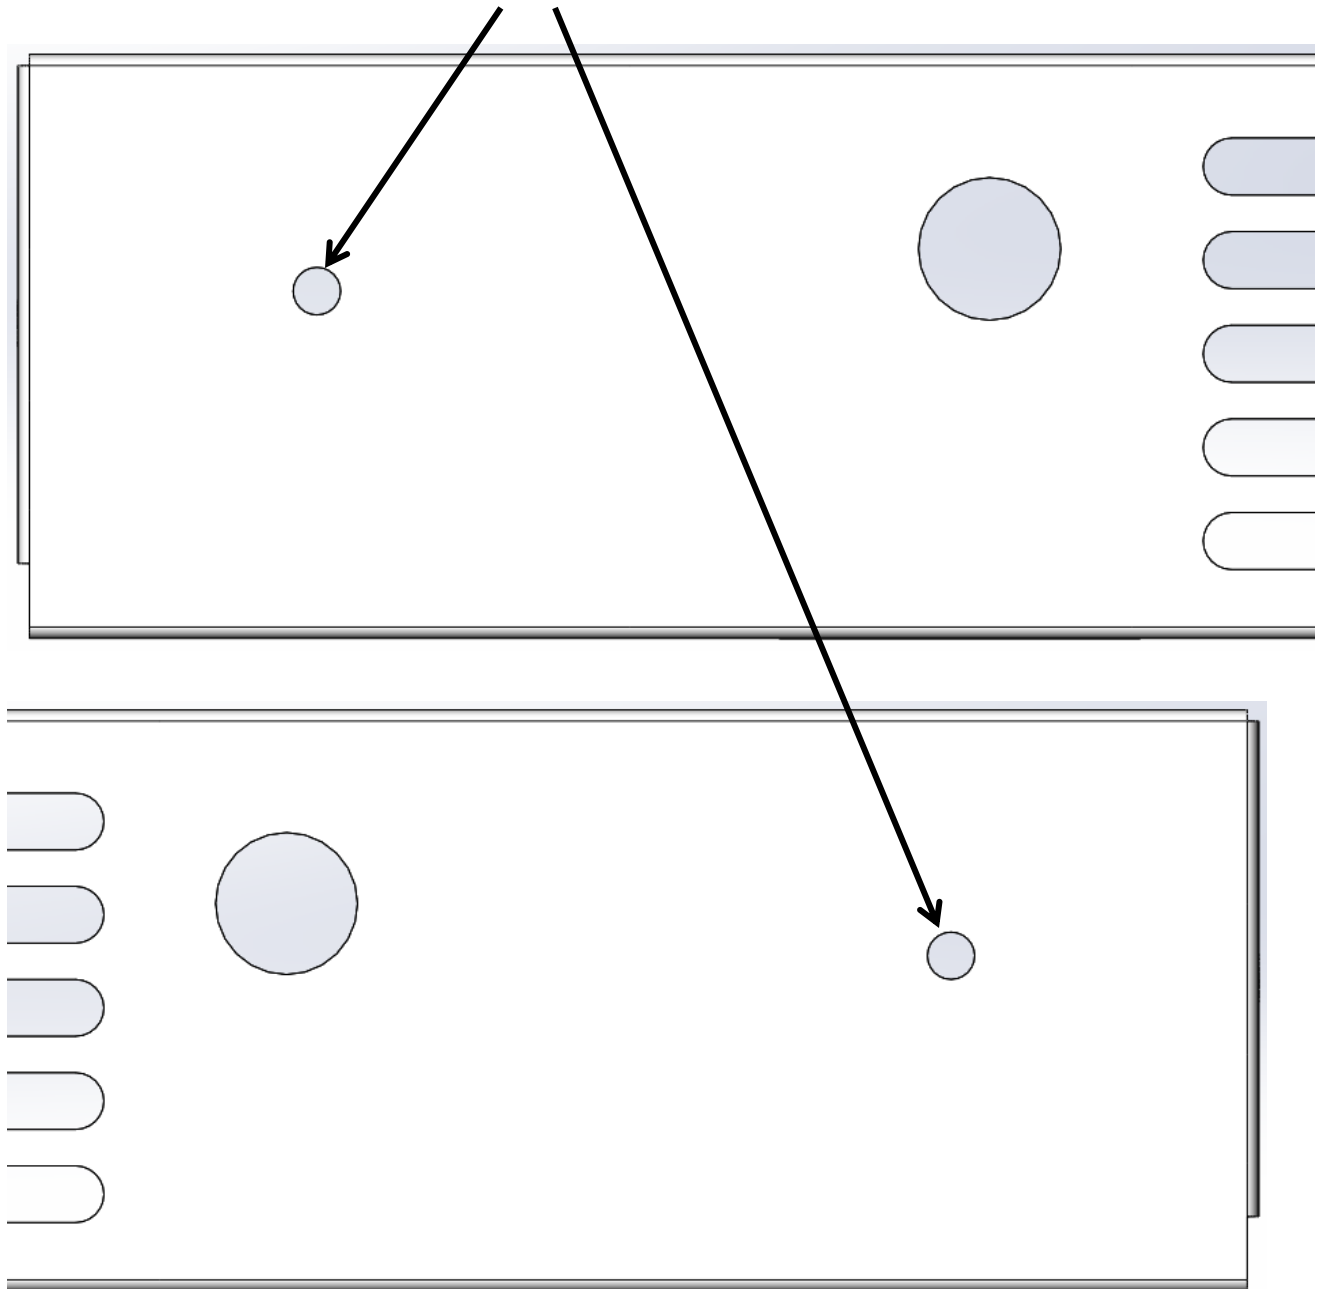
Step 3: Drill two ¼ inch diameter holes in locations shown. The images below are full size when printed, so the location can be marked using this page.

Step 4: Reinstall panel and install screws in holes that were added to panel.
